**PROGRESS REPORT
SP-G1 EFFECTS OF PROJECT OPERATIONS ON
GEOMORPHIC PROCESSES UPSTREAM OF
OROVILLE DAM**

**Oroville Facilities Relicensing
FERC Project No. 2100**

APRIL 23, 2003

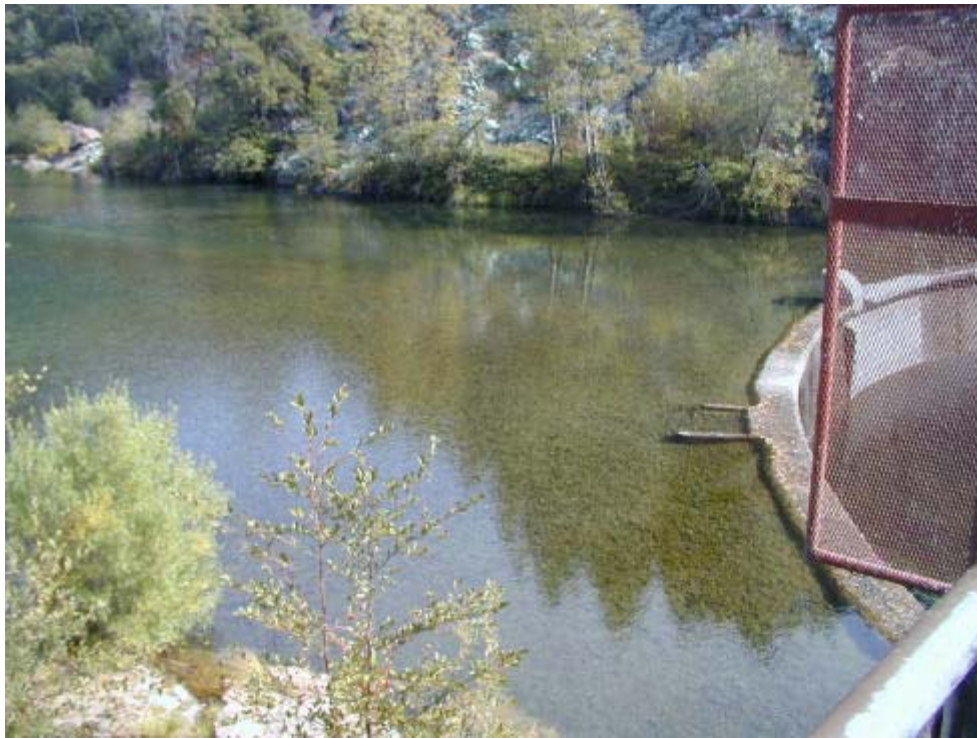
The reservoir behind Miocene Dam is almost completely full of sediment (Figure 4.2-6). The dam no longer functions as a significant sediment trap; clastics up to medium cobble-size appear to pass over the dam. A deep plunge pool occurs immediately downstream of Miocene Dam. Depths in the pool range from 5 to over 20 feet. The height of the dam above the pool is approximately 12 feet (Figure 4.2-7). Miocene Dam is maintained by P.G. & E. and diverts approximately 25 to 35 cfs into Miocene Ditch. In-stream gages on the West Branch near Miocene Dam are non-existent; however, during the day that Northern District staff hiked this portion, it appeared that over half of the total volume of flow was diverted in to the Miocene Ditch.

Figure 4.2-6. Trapped sediments behind Miocene Dam.

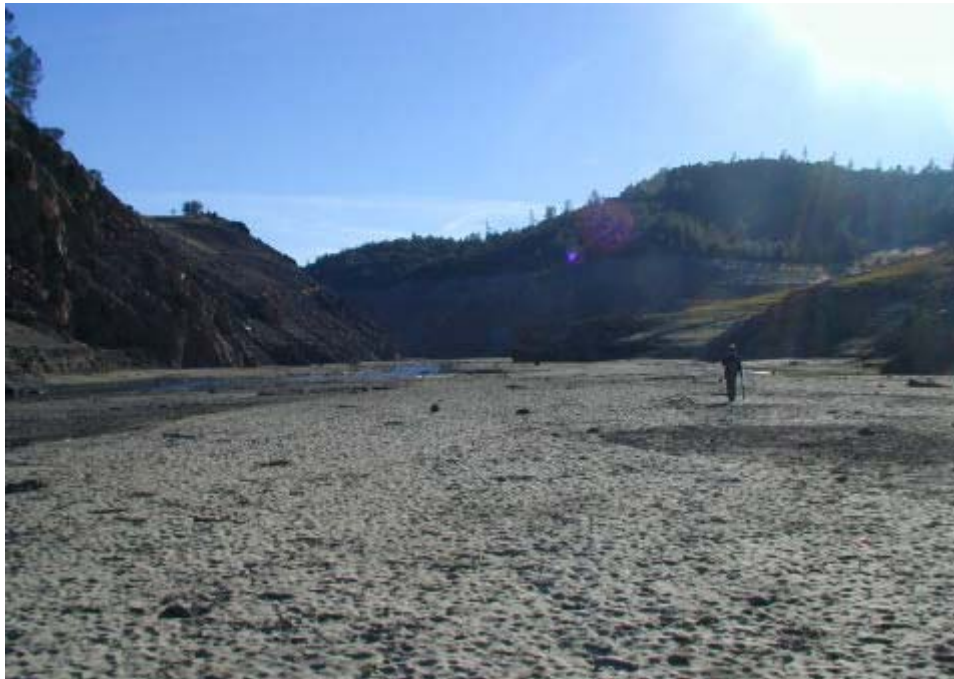
The sediment wedge on the West Branch stretches from Cape Horn approximately $\frac{1}{4}$ mile downstream (see Figure 4.2-10). The sediment wedge is composed primarily of medium to coarse sand with minor small pebbles and some cobbles. Fine silt covers the elevated portions of the wedge that have not been reworked by the river current as the lake elevation lowered (see Figure 4.2-11).

Figure 4.2-10. Upstream end of sediment wedge on West Branch ending at Cape Horn.

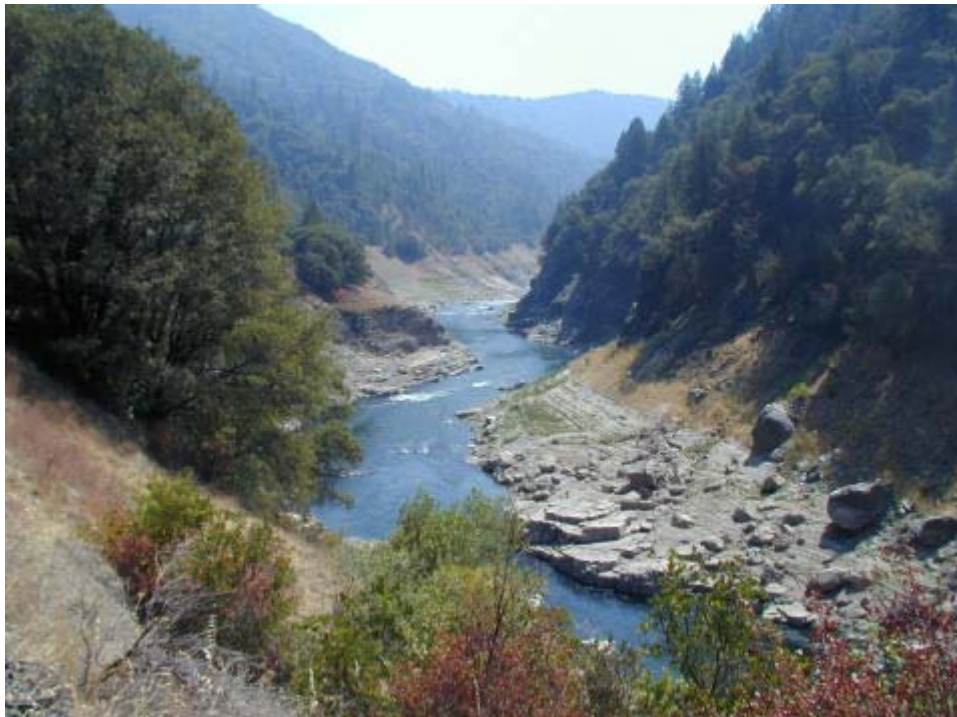
As a result of access difficulties, staff prepared an interim mesohabitat map based on aerial photography flown in April 1996 (see Appendix B, Sheets NF-1 through NF-5). Flow volume at the time of the photos is unknown, but, as stated before, flow varies greatly in the North Fork. Habitat mapping was completed for the river reaches starting at Big Bend Dam downstream about 4 $\frac{1}{2}$ miles, where the reservoir began in the aerial photos. The habitat type was predominated by runs (74%) and high gradient riffles and riffles (23%) (see Table 4.2-6). Only 3% of the typed reach was classified as pool. The high variability in flows makes the habitat typing difficult. For example, Figures 4.2-20

and 4.2-21 show reaches that were typed as runs or high gradient riffles based on the 1996 aerial photography, but may actually be a series of pools, riffles, and runs at a lower flow.

Figure 4.2-20. Reaches 217 & 216 on North Fork.

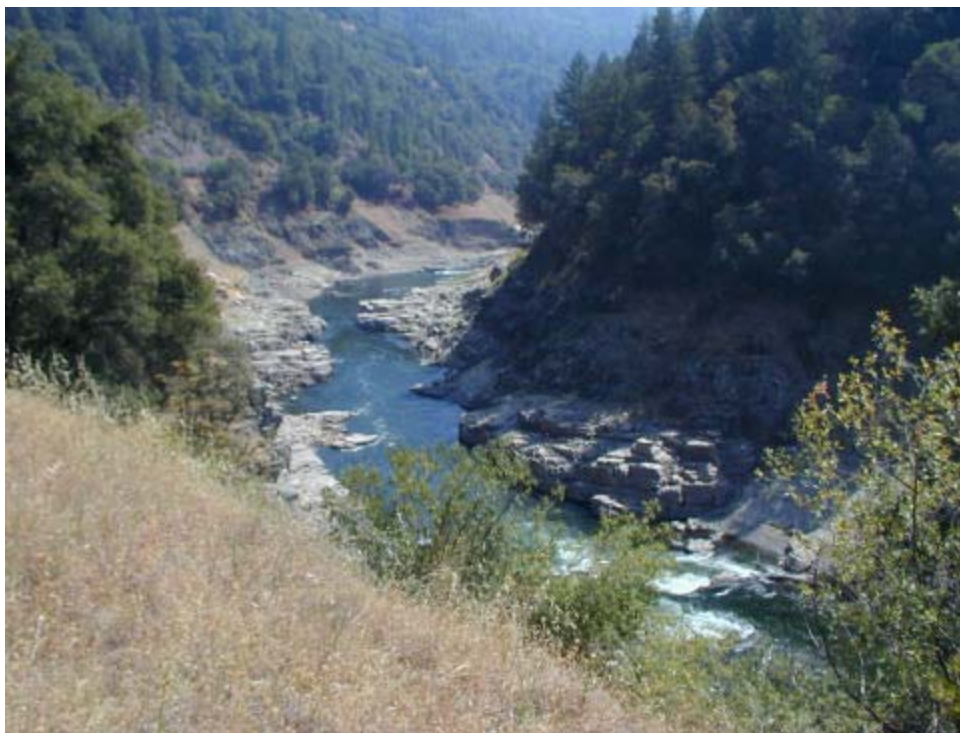
Figure 4.2-21. Reaches 215 & 214 on North Fork.

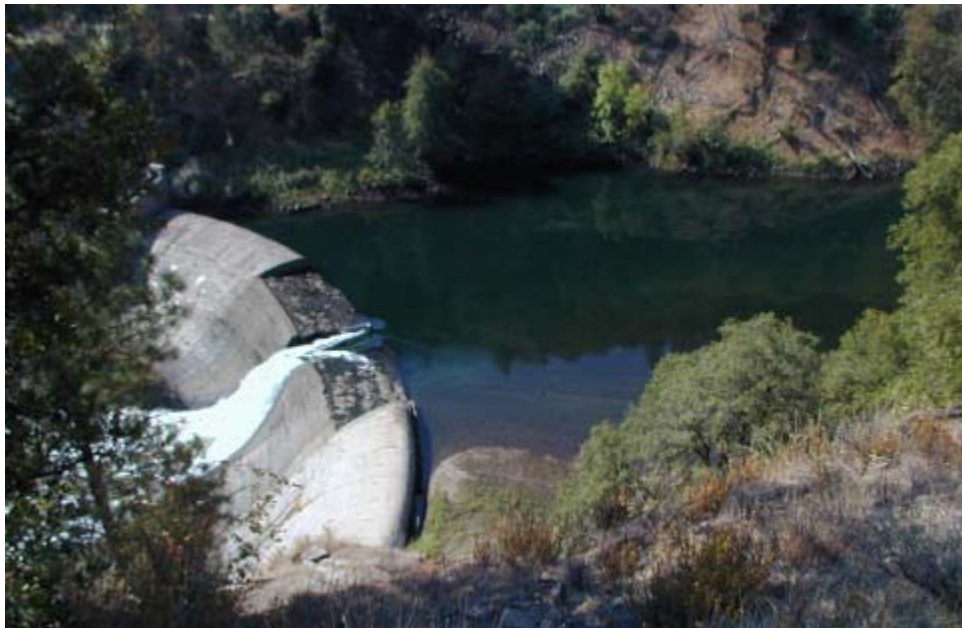
The presence of a very large sediment wedge on the North Fork indicates that significant quantities of sediment are not being retained upstream. Big Bend Dam is nearly full of sediment (Figures 4.2-22 and 4.2-23); bed load sediment is most likely passing over the dam during high winter storm flows.

Figure 4.2-22. Big Bend Dam with retained sediment.

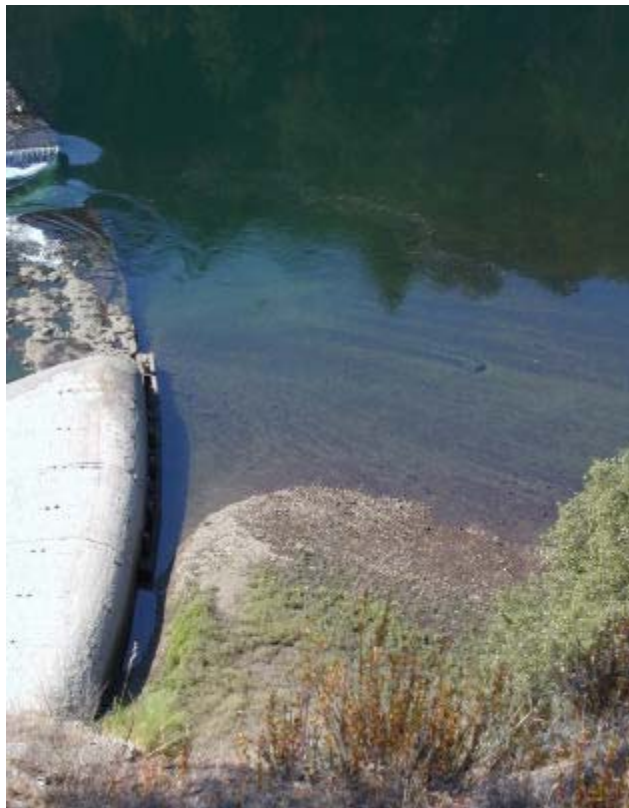
Figure 4.2-23. Coarse grained sediment behind Big Bend Dam.

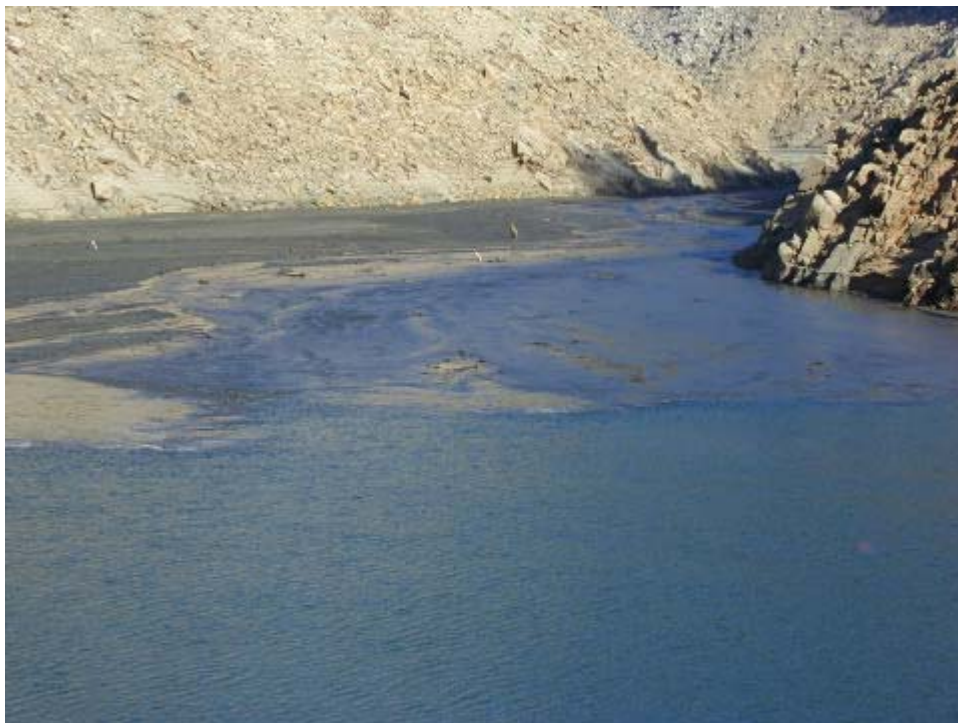
The sediment wedge filled the entire river channel at the point where it entered Lake Oroville (see Figures 4.2-24 and 4.2-25) and was at or near the current lake level. Flows in the Middle Fork were sufficient to continually work over the entire width of the wedge and erode it down to the current lake level. This phenomenon is similar to the continual reworking of the North Fork sediment wedge where flows are also sufficient to erode the entire width of the wedge.

Figure 4.2-24. Middle Fork sediment wedge entering lake showing constant grade adjustment with lake level.

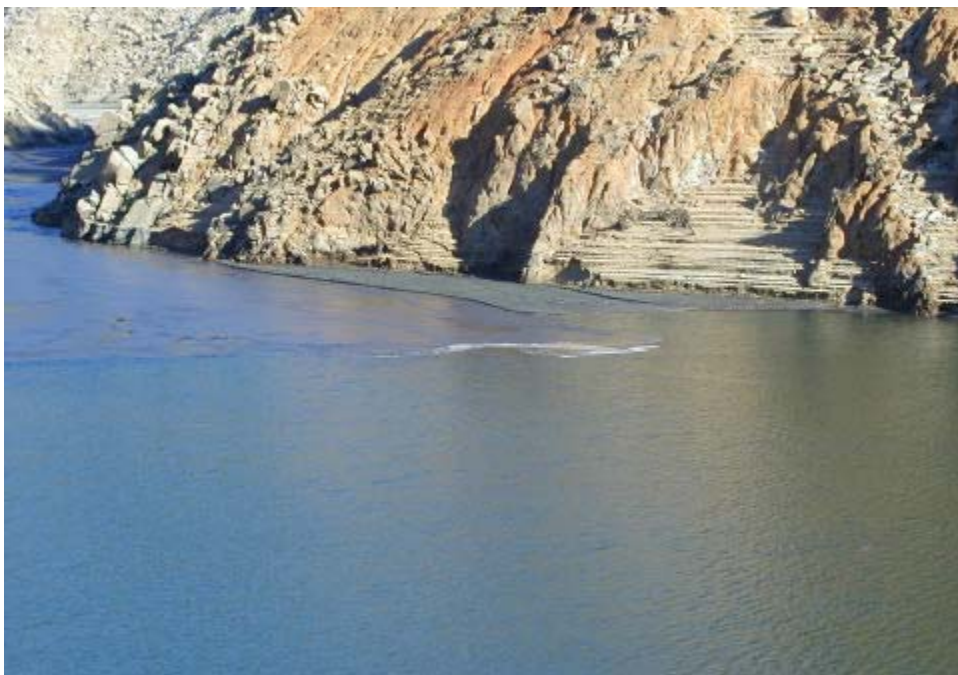
Figure 4.2-25. Middle Fork sediment wedge.

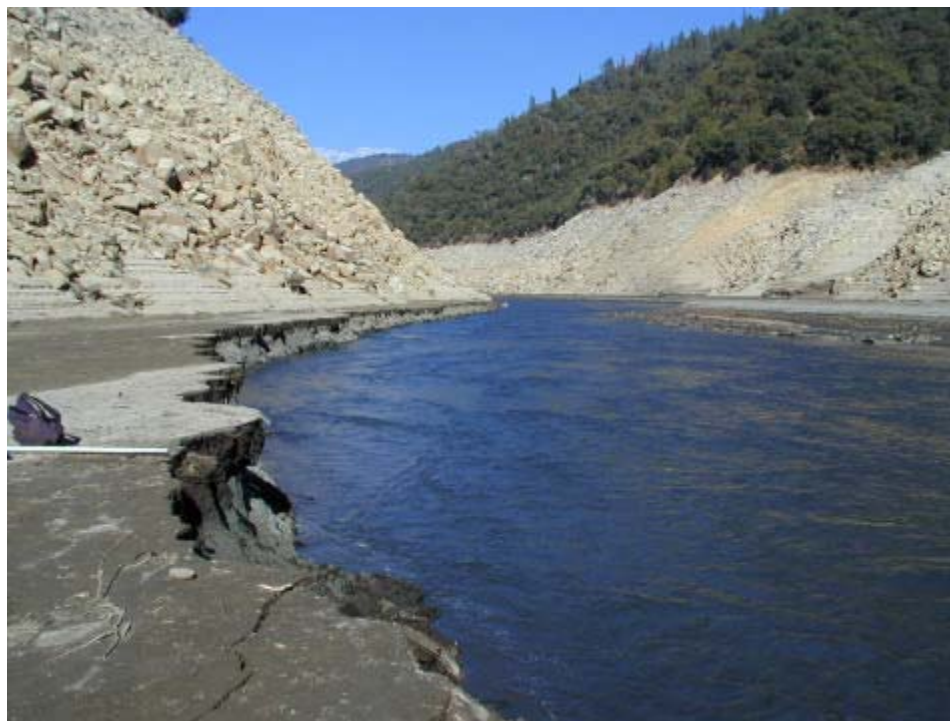
Figure 4.2-26 shows a portion of the wedge about halfway up its length with wedge deposits three to five feet above the level of the river. The upper foot of the wedge is fine grained (i.e. fine sand to silt) and contains layers of organic material (see Figure 4.2-27).

Figure 4.2-26. Middle Fork sediment wedge showing side bank of non-eroded sedimentary material.

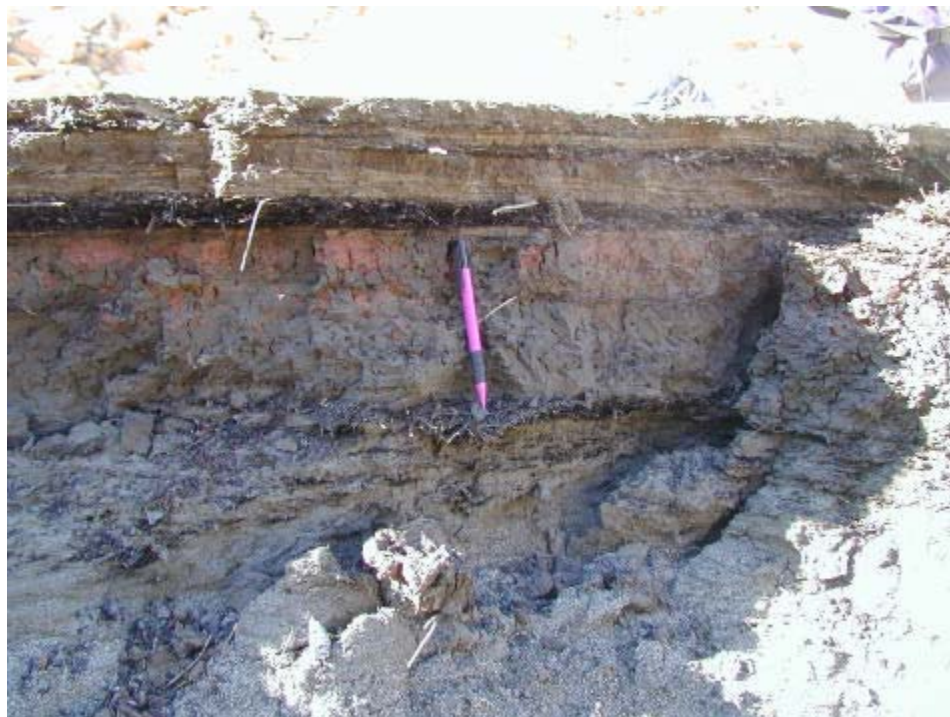
Figure 4.2-27. Middle Fork sediment wedge material profile.

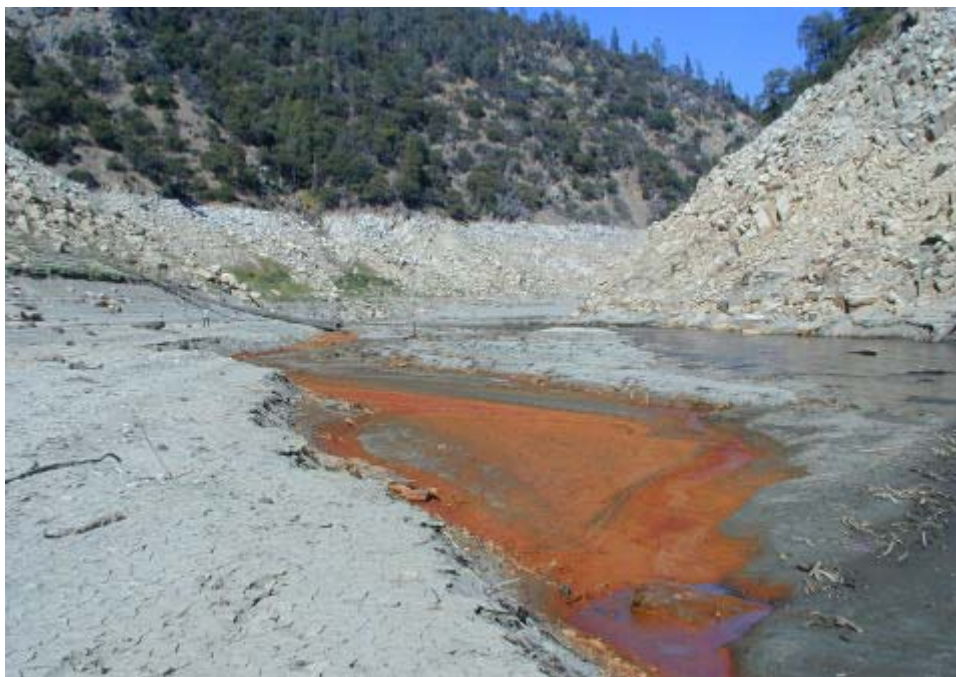
The sediment wedge continued approximately 6500 feet upriver (see Figure 4.2-28) to a point where the channel narrows and gravel, cobbles, and bedrock comprise the bulk of the stream substrate. Mesohabitat typing began at this point and continued upriver about 3600 feet. Access difficulties (see Figure 4.2-29) and time constraints prevented further typing upstream.

Figure 4.2-28. Upstream end of Middle Fork sediment wedge.

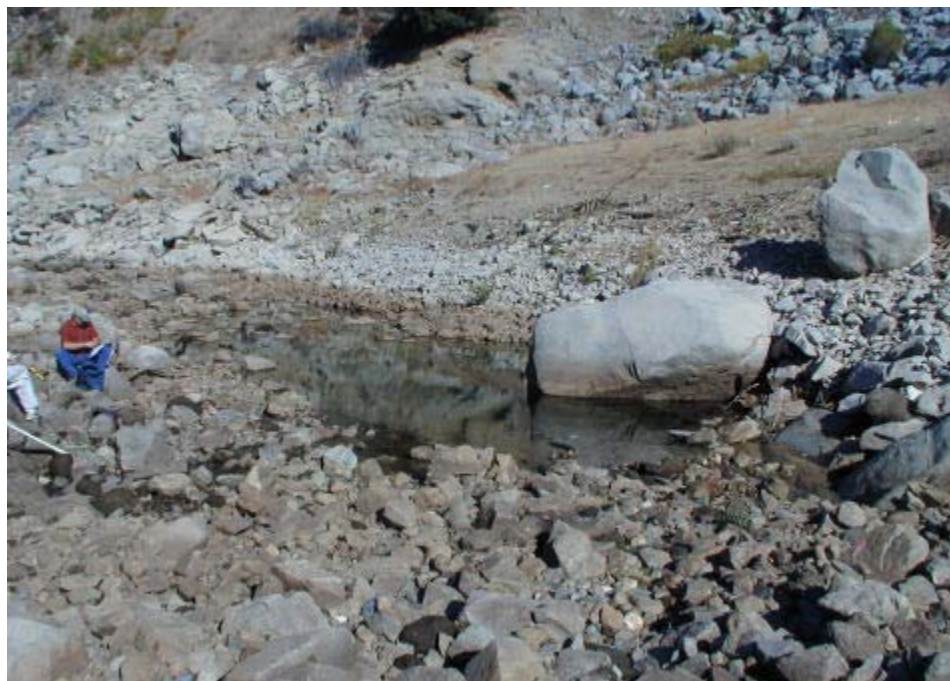
Figure 4.2-33. Reach 93 looking downstream. Note water stain about two feet high.

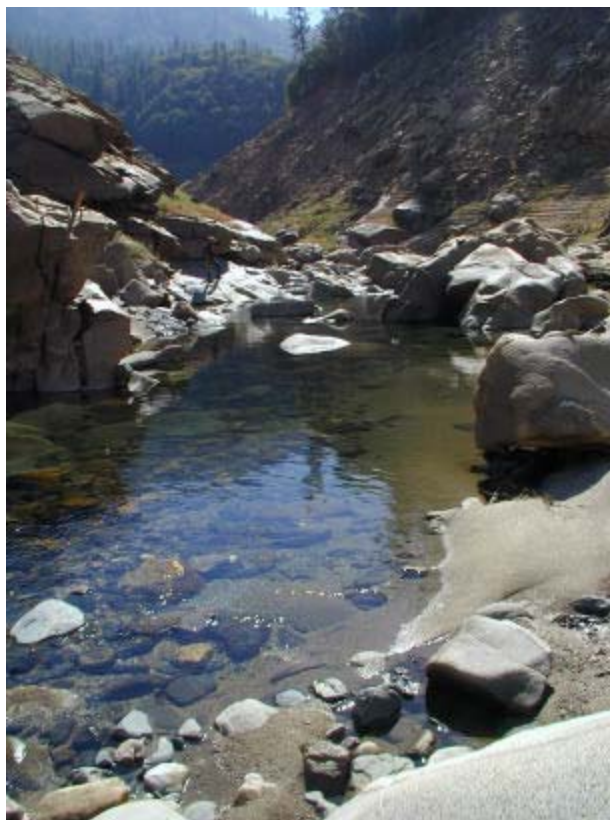
Many of the pools are bedrock controlled with a steep run or cascade at their downstream ends. Figure 4.2-36 shows a pool (Reach 120) with a sand and gravel substrate flowing into a bedrock controlled cascade. Lower portions of the typed reach have substrates with increasing proportions of fine to coarse sand. The increase in sand content is probably due to the erosion of a remnant sediment wedge lining the sides of the channel as seen in Figure 4.2-37.

Figure 4.2-36. Bedrock controlled pool (Reach 120) ending in a bedrock cascade.

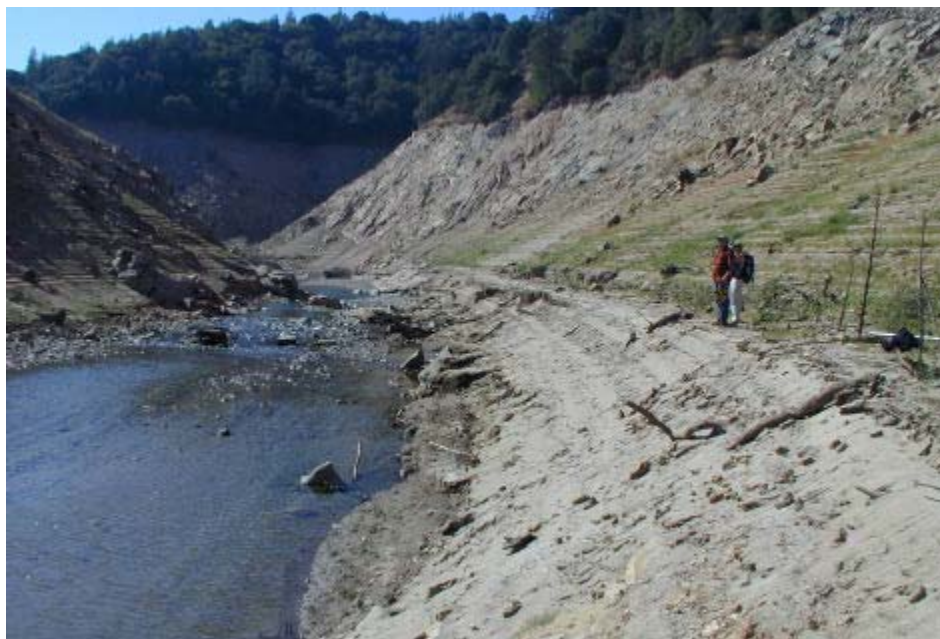
Figure 4.2-37. Degraded habitat due to erosion of remnant sediment wedge.
